Manhole Inspection Summary

Manhole # S41Y1_027MH

Insp Date: **4/21/08 11:02 AM**

Location Address: **728 Pontiac Ave.**

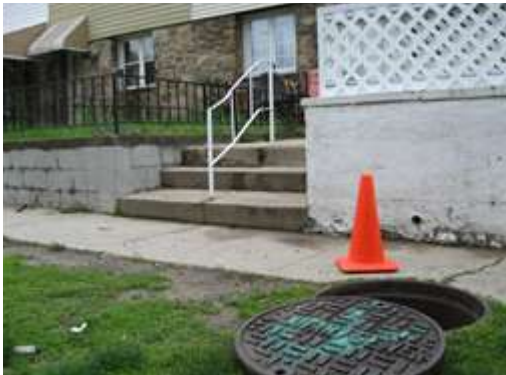
Location View

728 Patapsco-Pontiac Alley

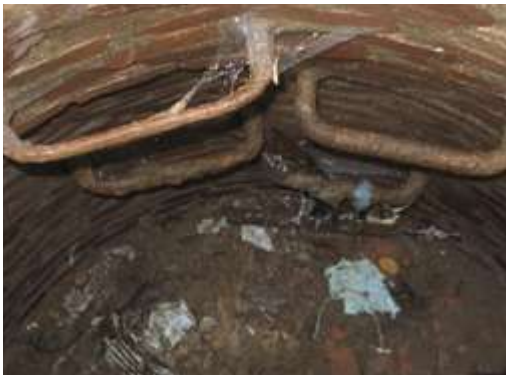
Steps Count: **4** Missing: **0** ☒ **Corroded**

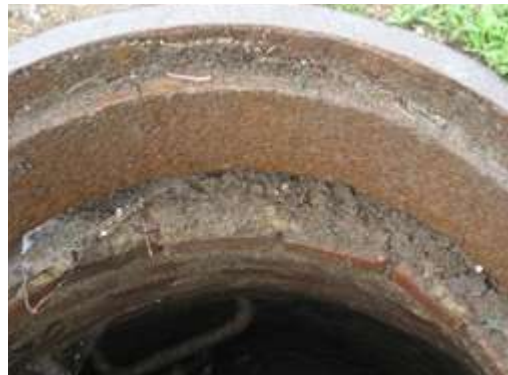
Defect 1

Condition: ☐ Sound ☐ Cracked ☐ Root Intrusion ☐ Loose Brick ☒ **Deteriorated**

Infiltration: ☐ None ☒ **Joint** ☐ Cracks ☐ Mortar ☐ Roots ☐ Wall

Frame-Chimney Offset and cracked joint

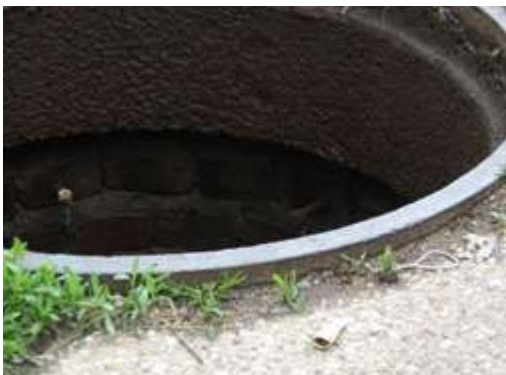
Defect 2

Frame above the grade

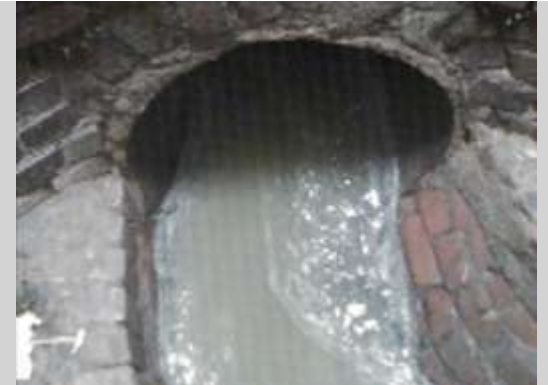
12 O'Clock Outflow

21 in. Circular Gravity Sewer
Pipe Out @ 12 O'Clock

Pipe Height: **20.4** (in.) Rod and Bar (Angled)
Pipe Material: **Clay** ☐ Pipe Lined
Invert Depth: **9.00** (ft.) Flow Characteristics: **Turbulent**
Deposits: ☒ None ☐ Mud ☐ Sludge ☐ Debris ☐ Grease
Silt Depth: (in.) Deposits Extent:
Infiltration: **None** Pipe Seal Cond: **Cracked**

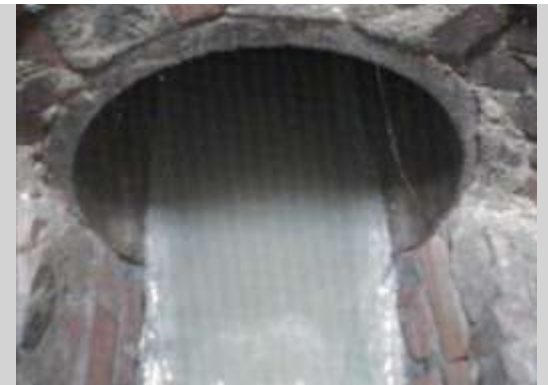
5 O'Clock Inflow

21 in. Circular Gravity Sewer
Pipe In @ 5 O'Clock

Pipe Height: **20.4** (in.) Rod and Bar (Angled)
Pipe Material: **Clay** ☐ Pipe Lined
Invert Depth: **8.82** (ft.) Flow Characteristics: **Fast**
Deposits: ☒ None ☐ Mud ☐ Sludge ☐ Debris ☐ Grease
Silt Depth: (in.) Deposits Extent:
Infiltration: **None** Pipe Seal Cond: **Sound**
